KURRI current status

08. 04. 2015 ishi

LINAC repair work still going on
1. replacement of the rf window done

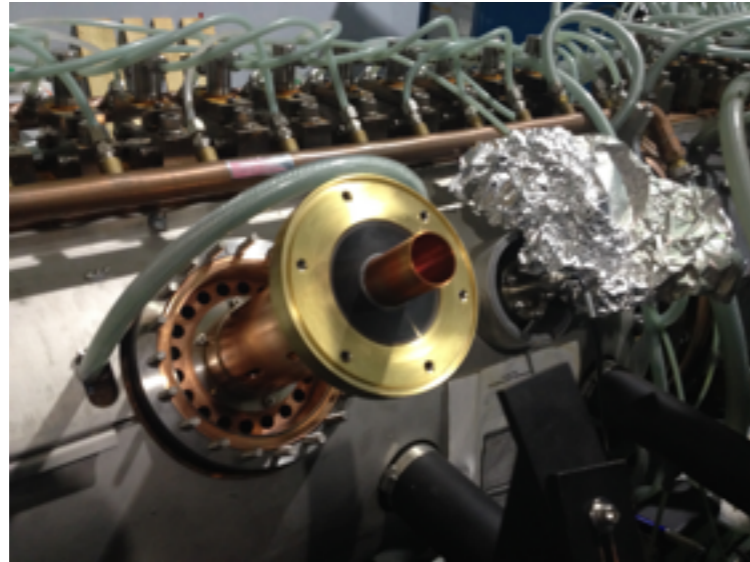
before replacement

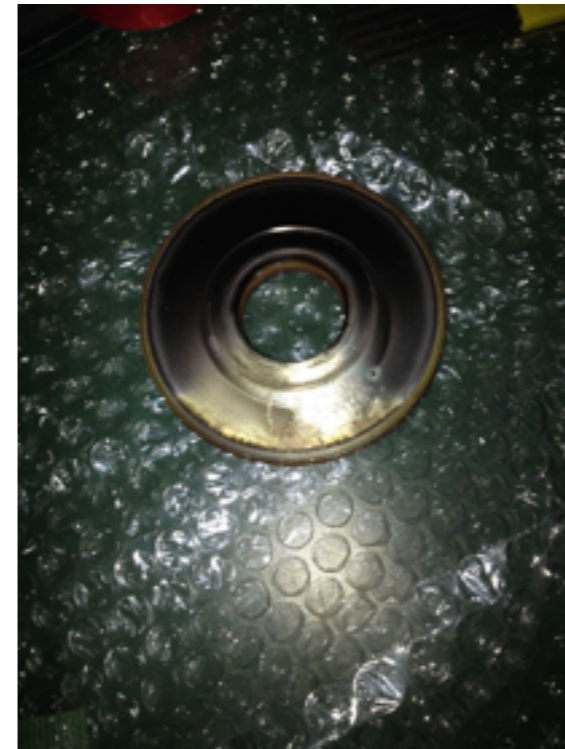
damaged window

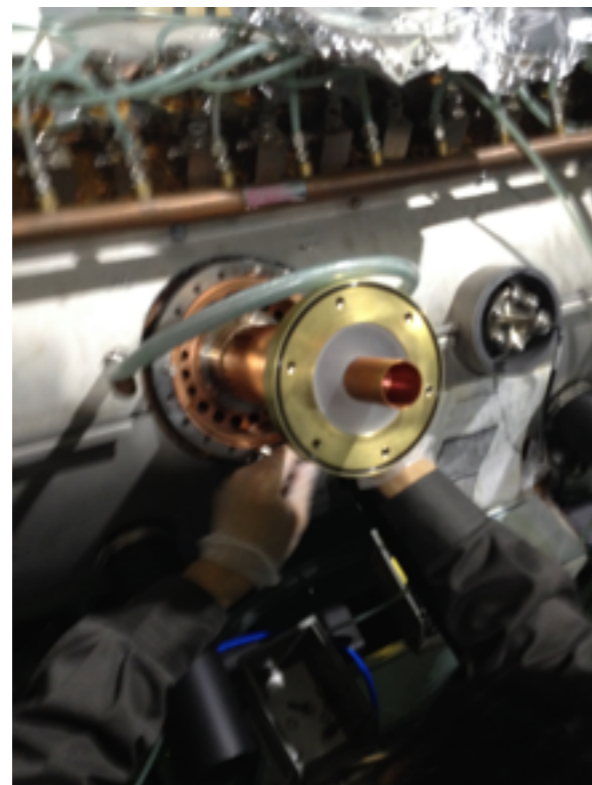
after replacement

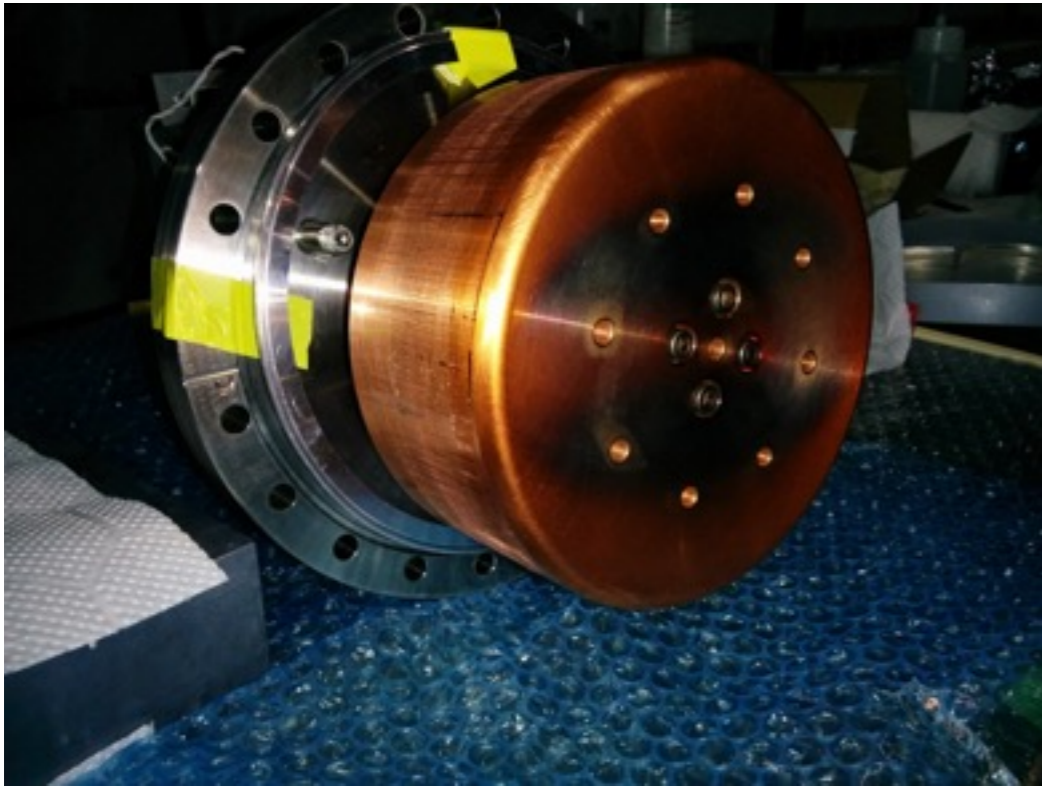
slug tuner pulled
out of DTL1

2. Repair slug tuner

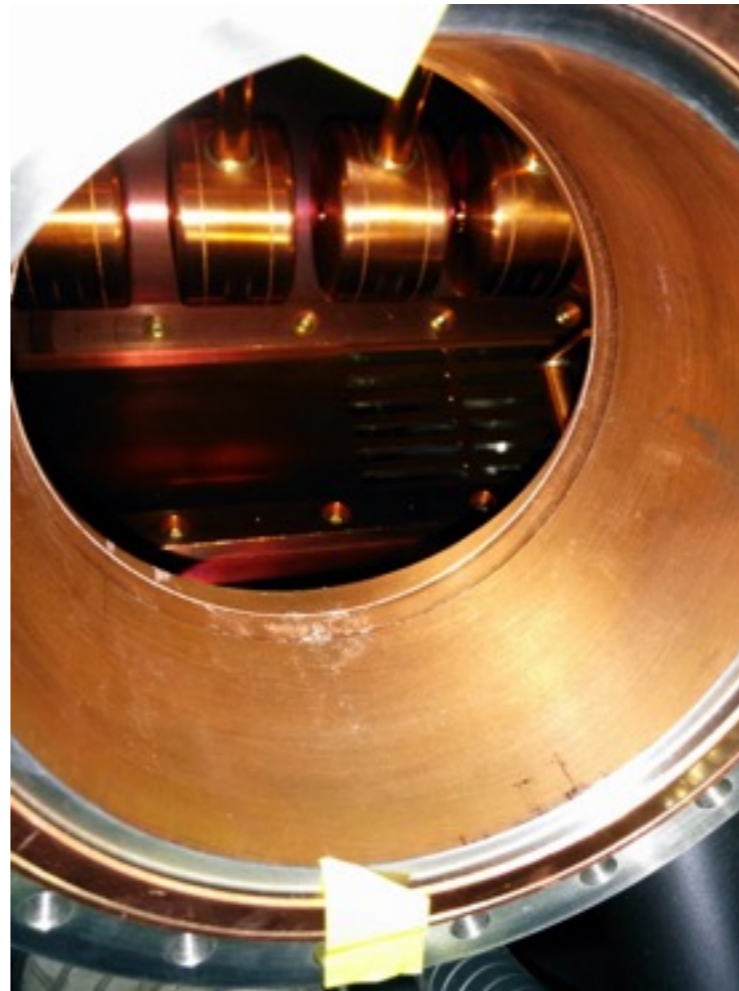
scratch marks

repair has been done with a brand new rf finger
and polishing the surface of the tuner

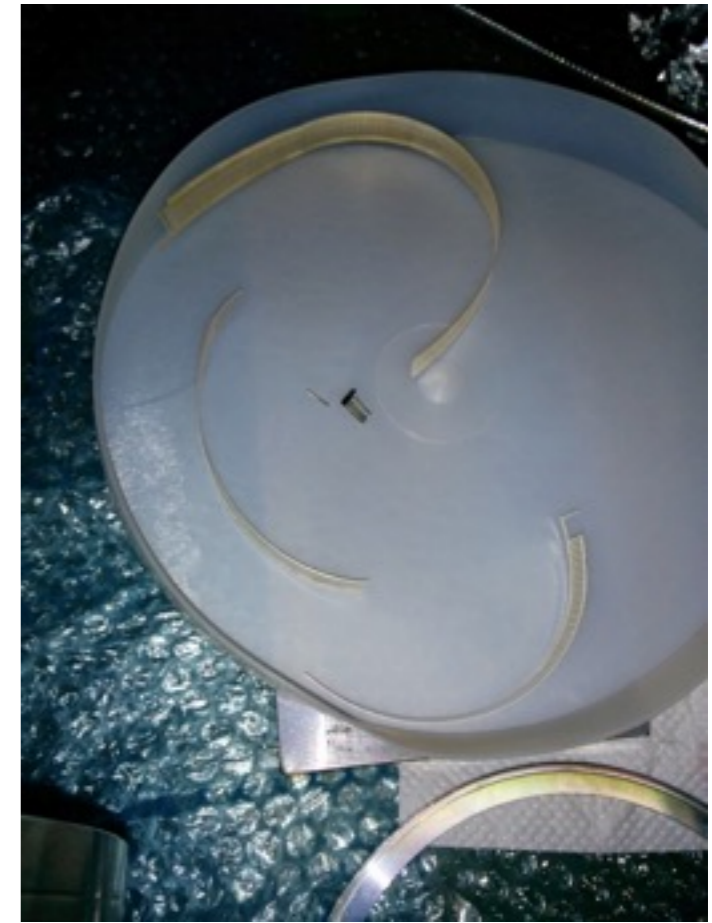
broken rf finger

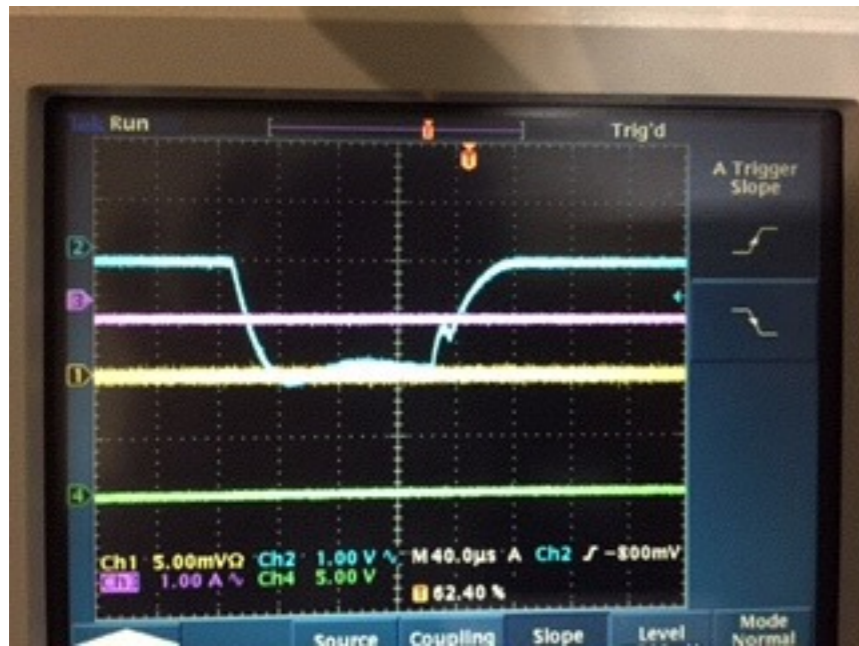
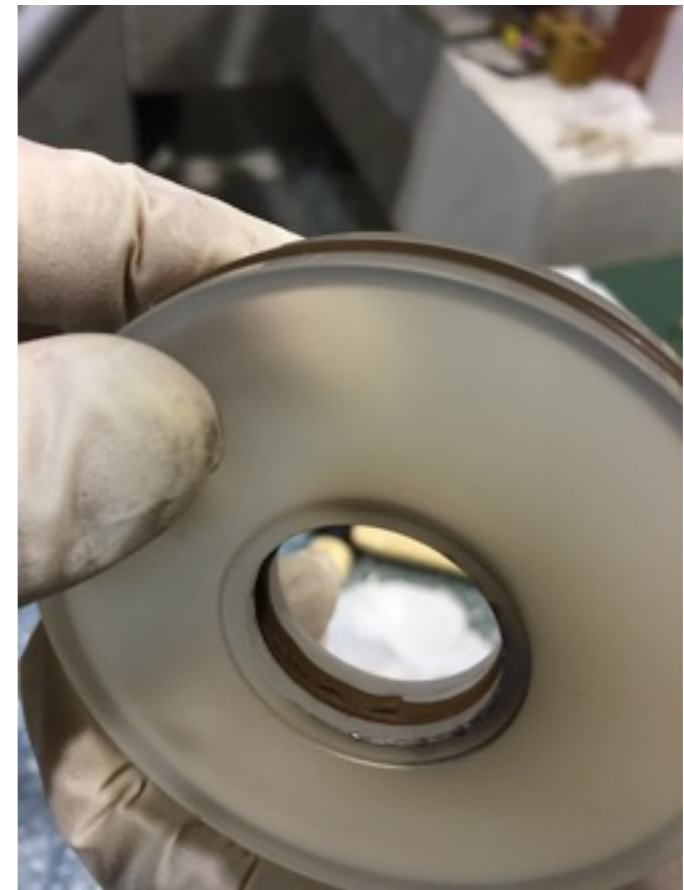
but vacuum trouble right away

because of damaged o-ring

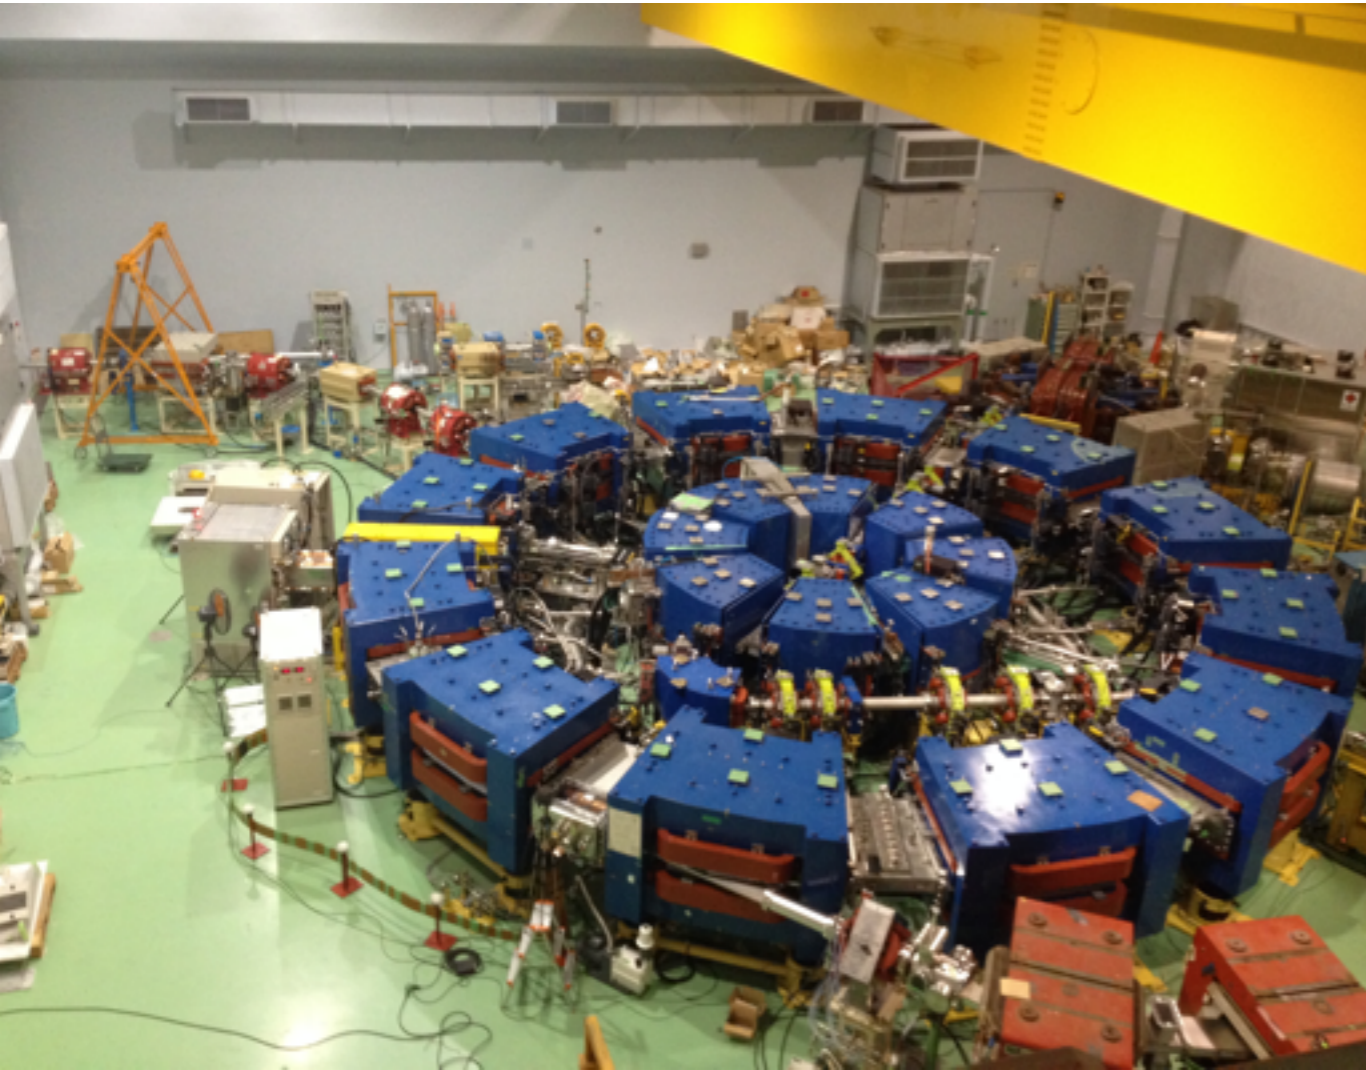
before

Remove obsolete magnets and bases

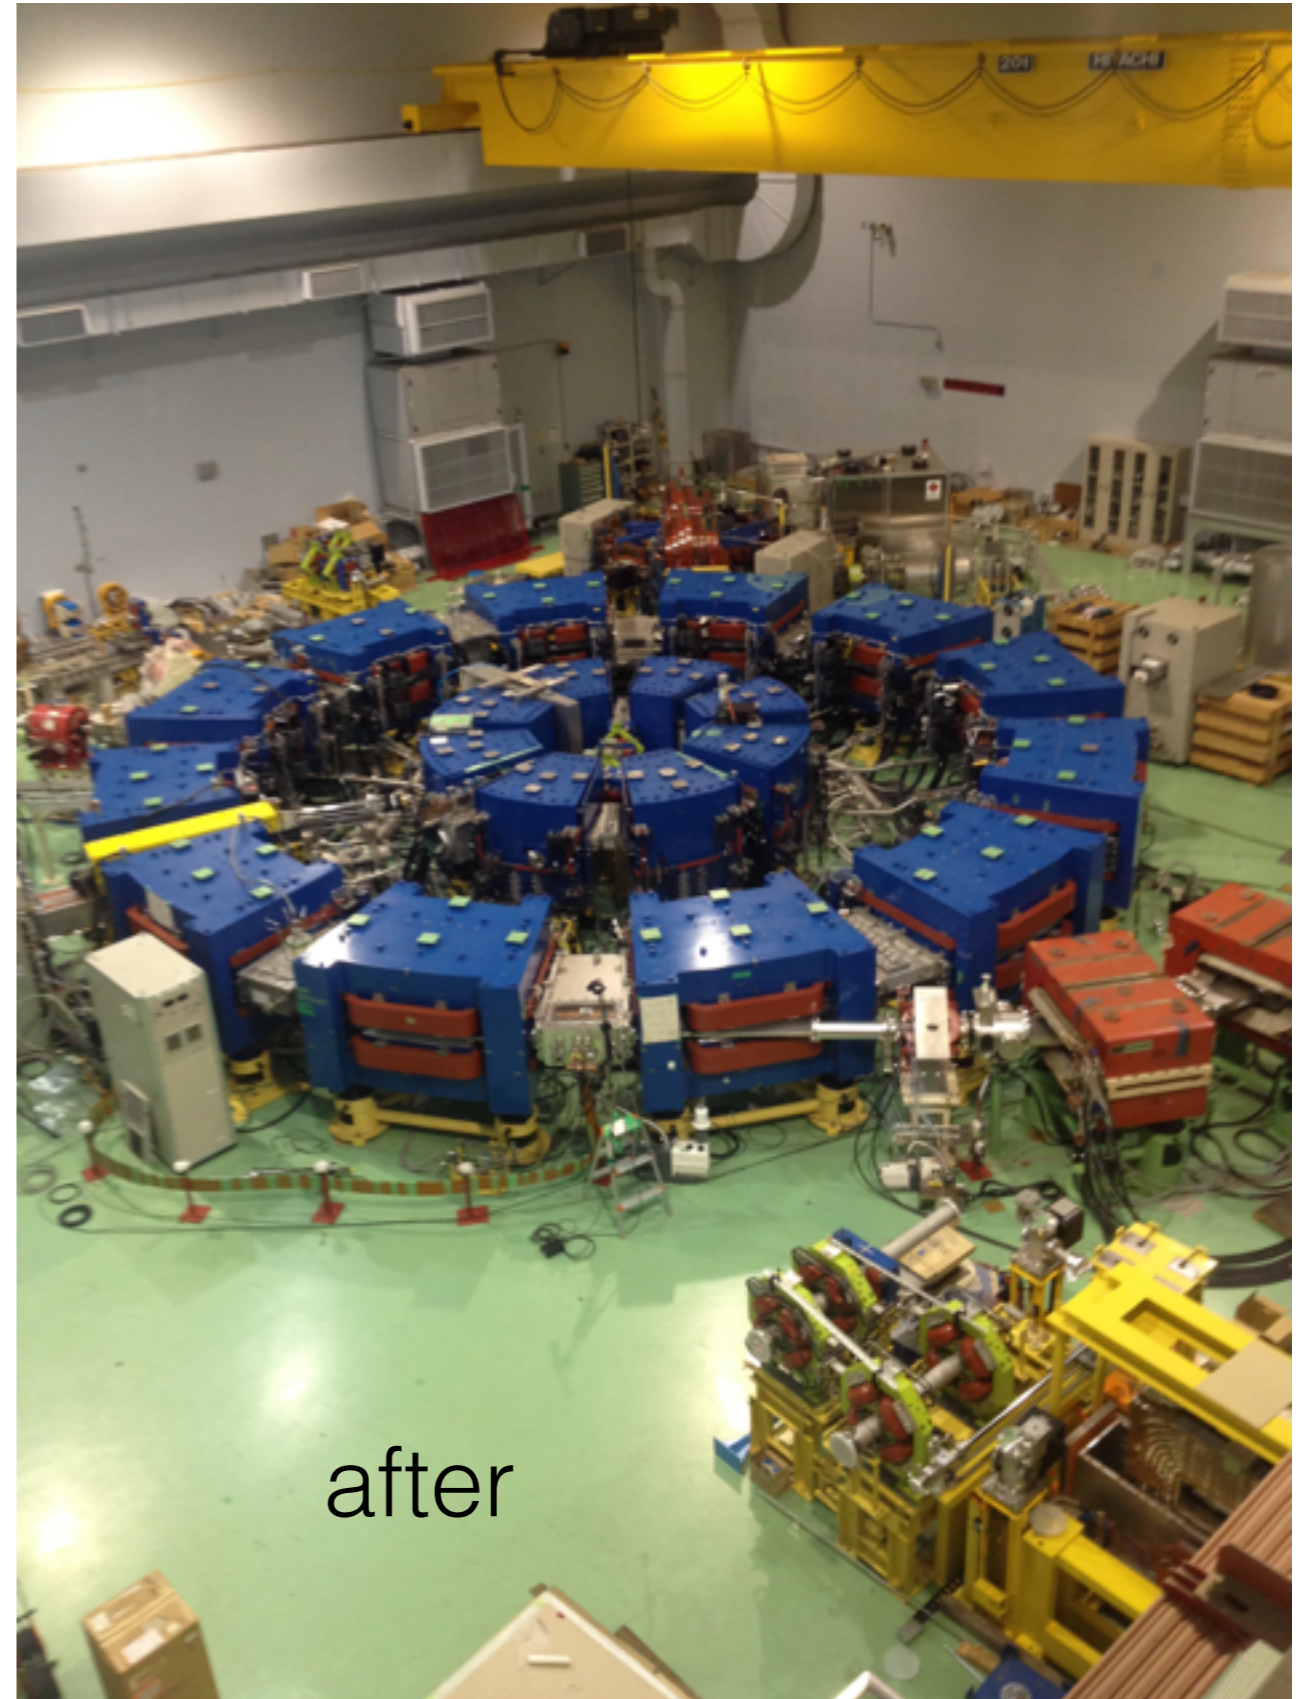
after

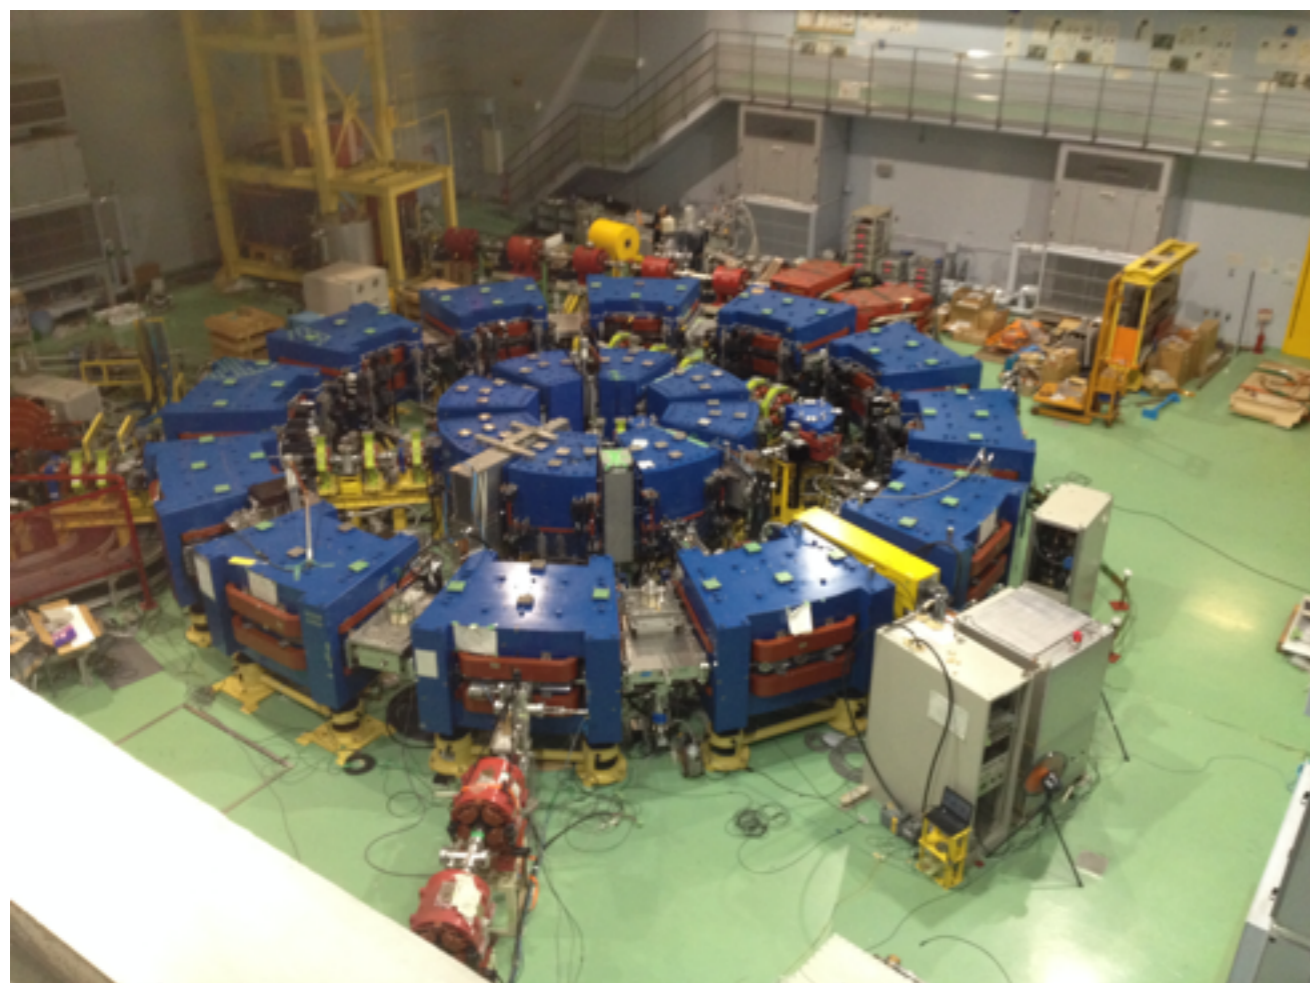
before

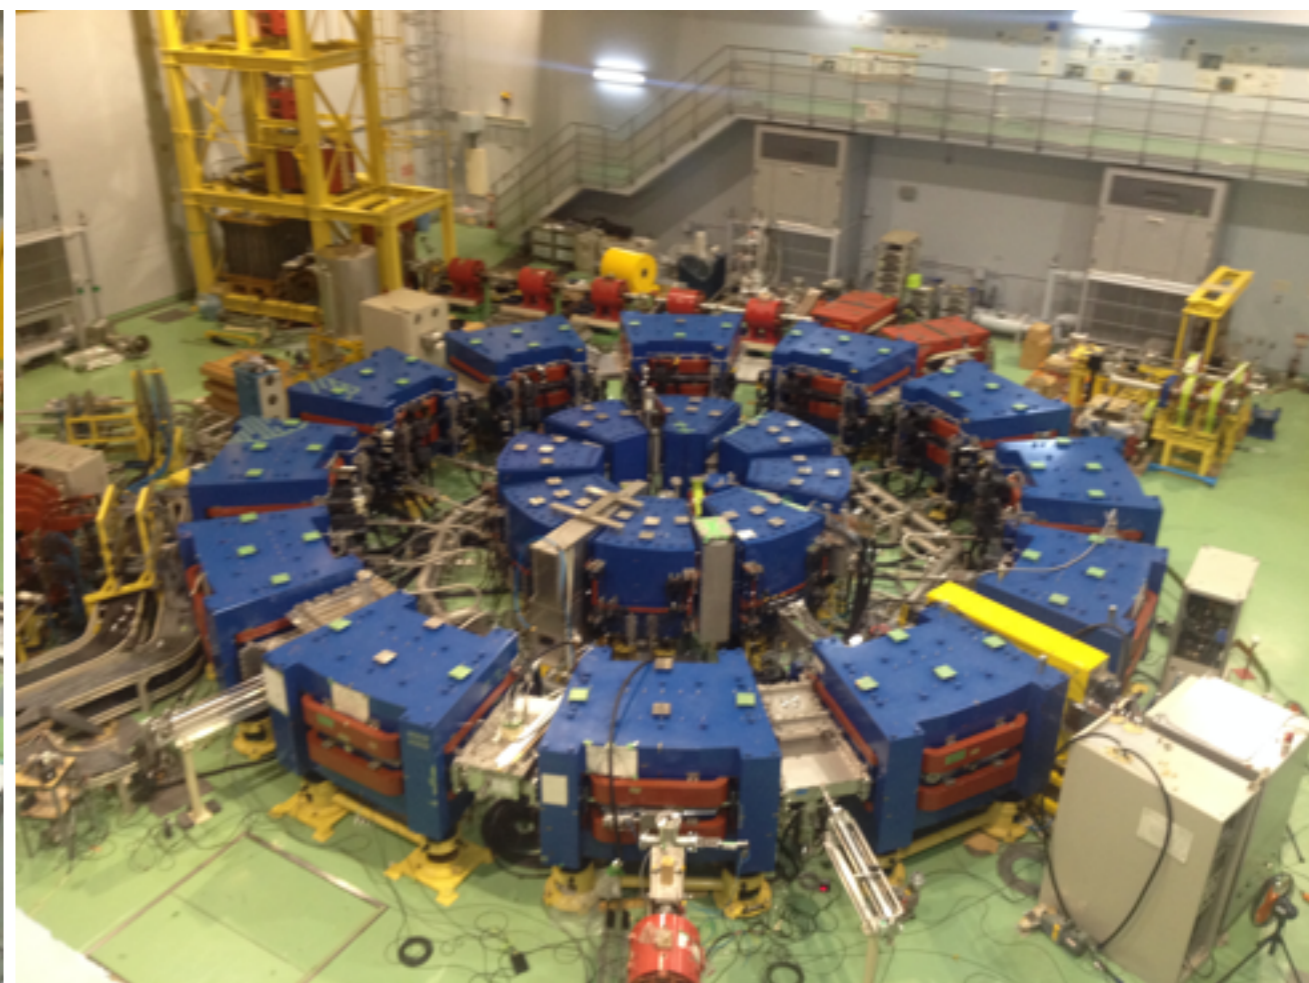
after

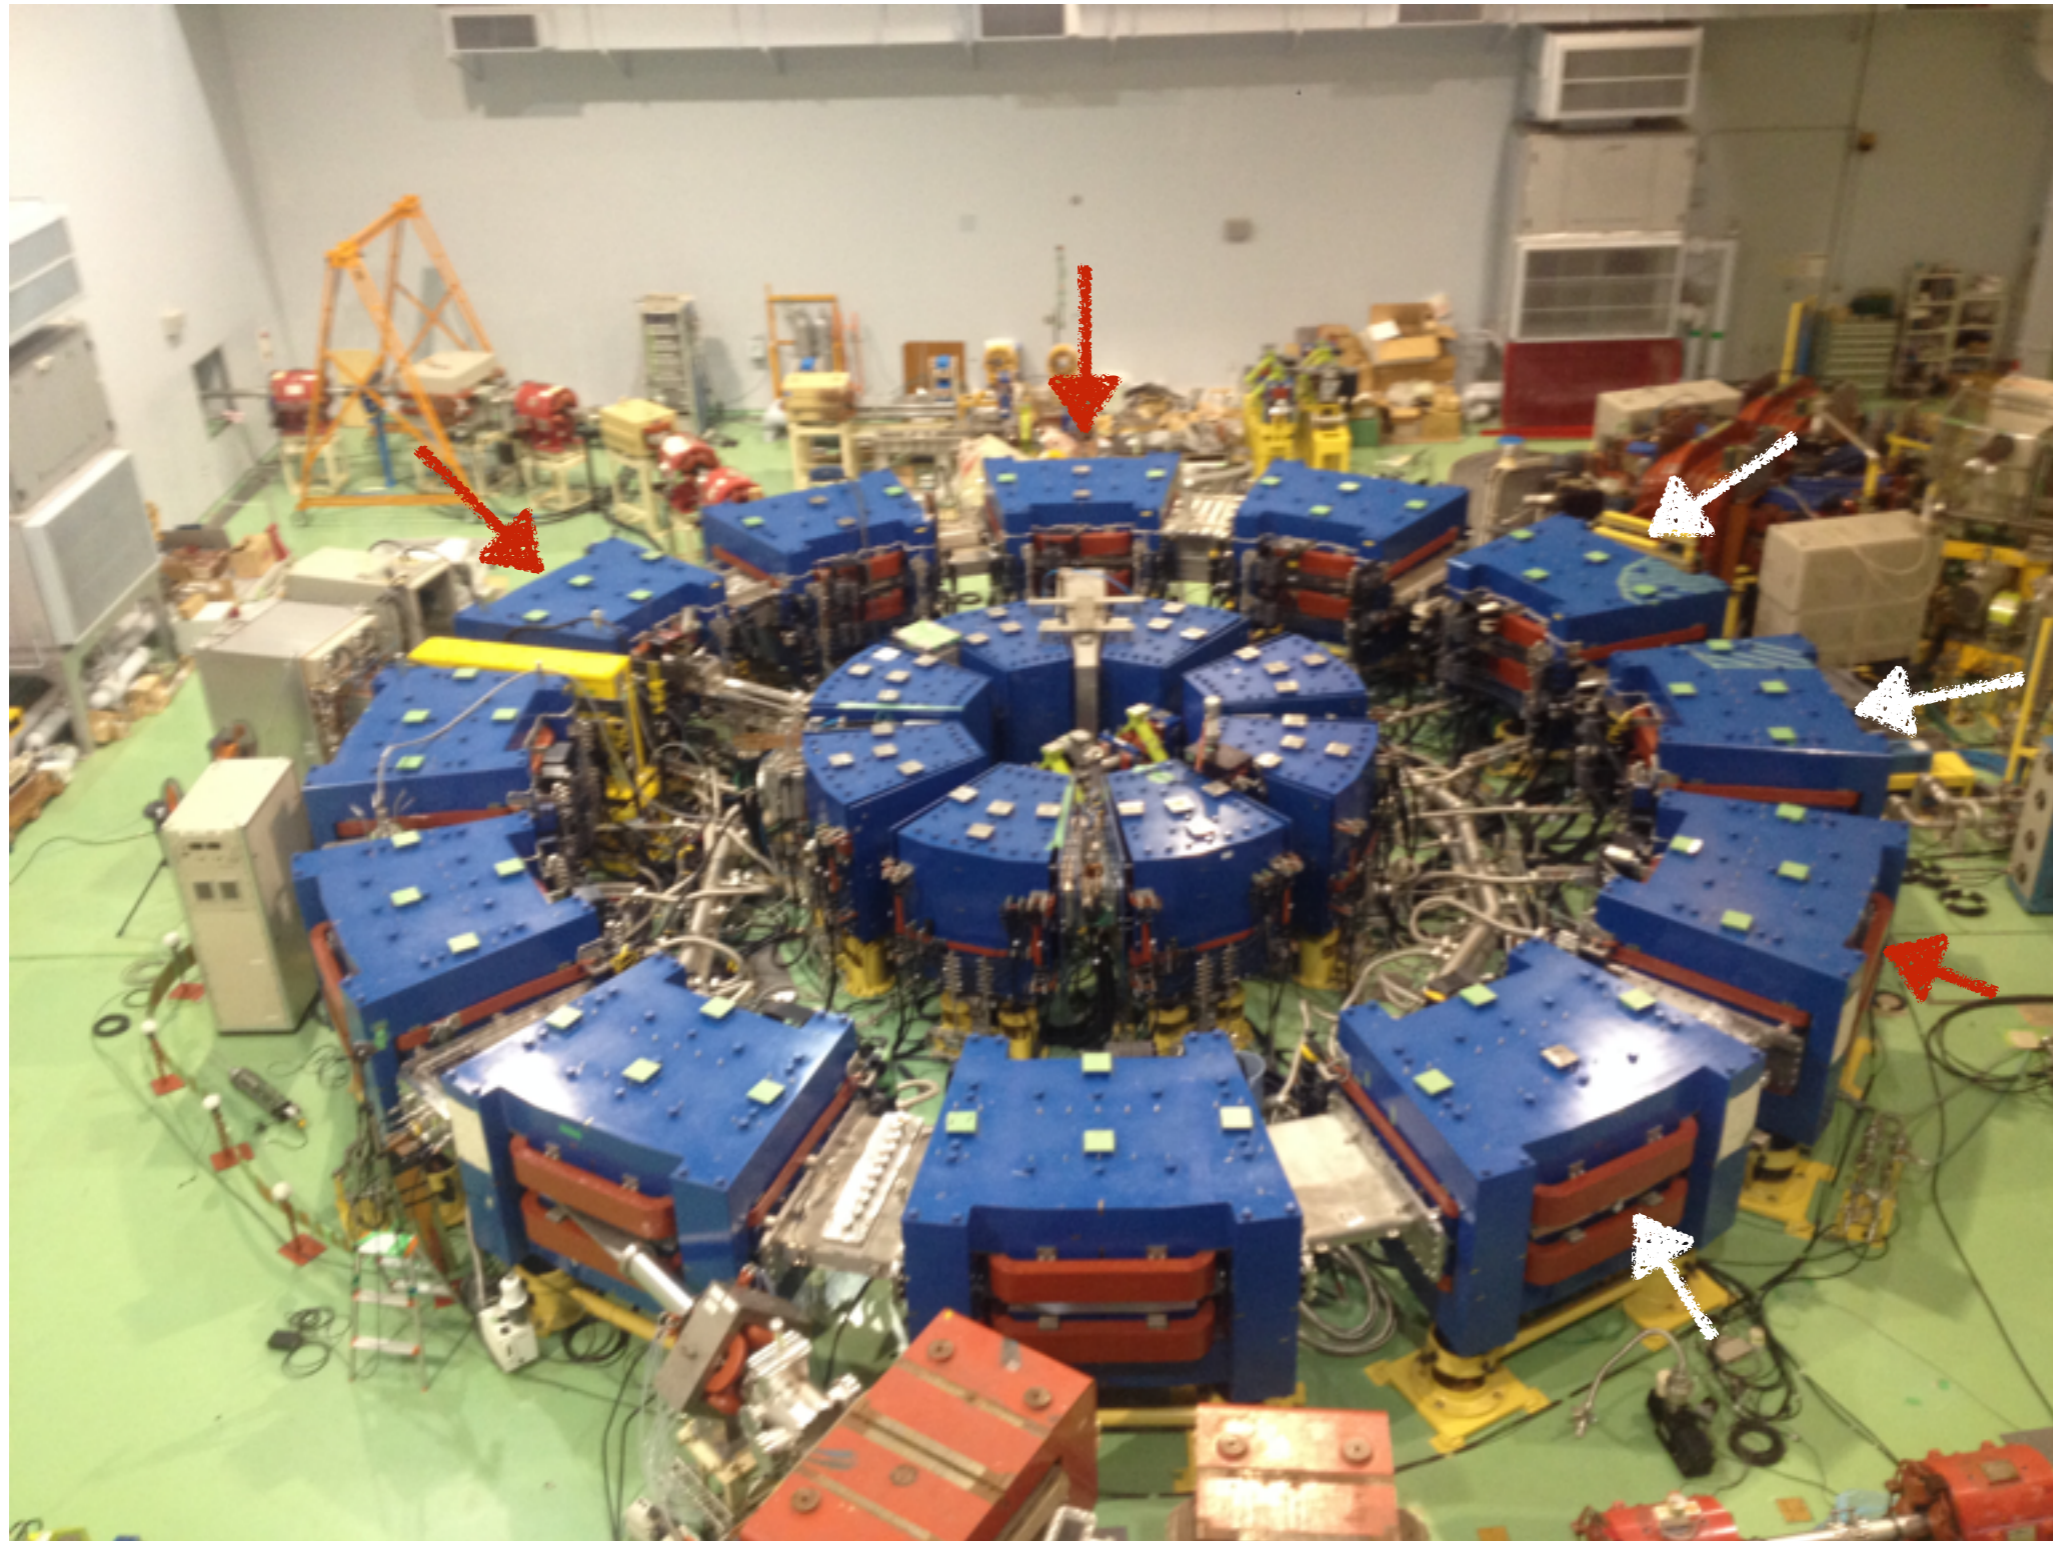
red:already
white:added

made 3 additional probe ports
