Status of RFQ

28.04.2016 y.ishi

What we did with the damaged resonator
(nothing has been done with the healthy one)

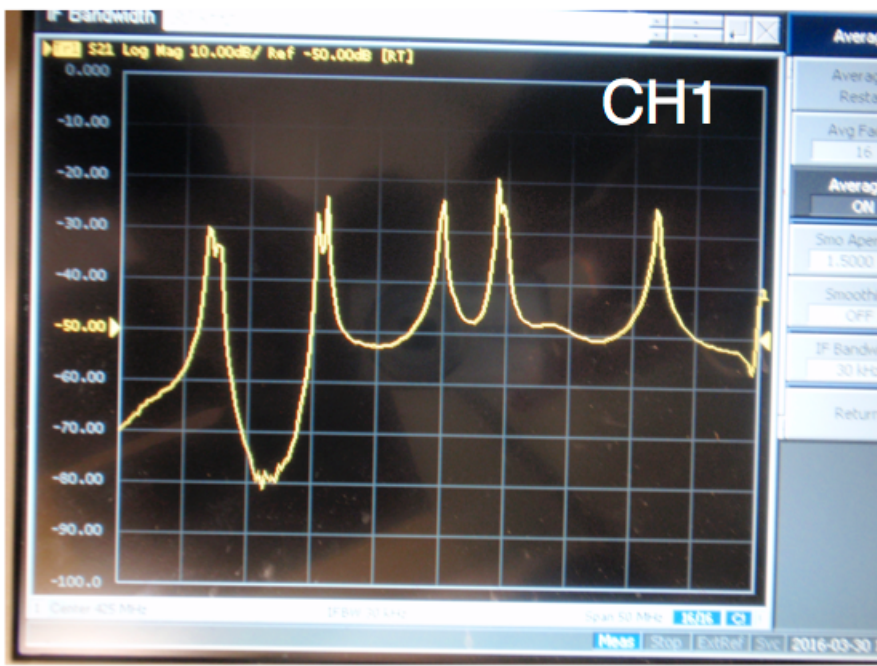
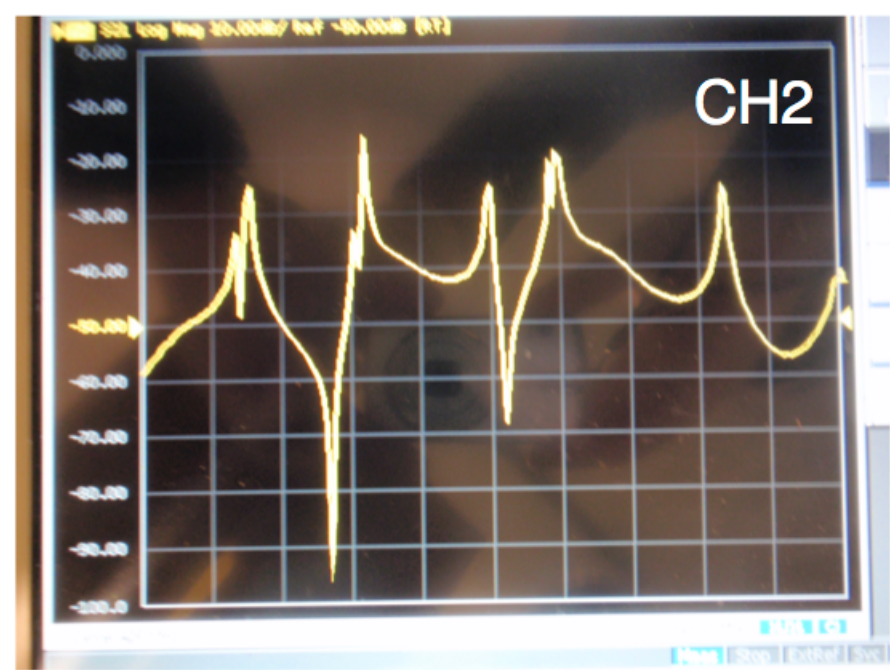
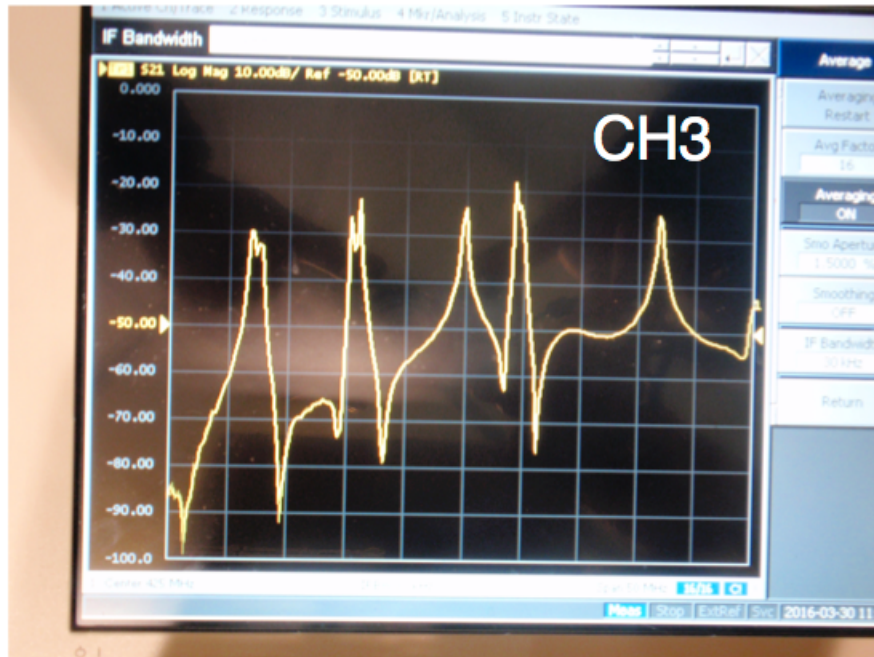
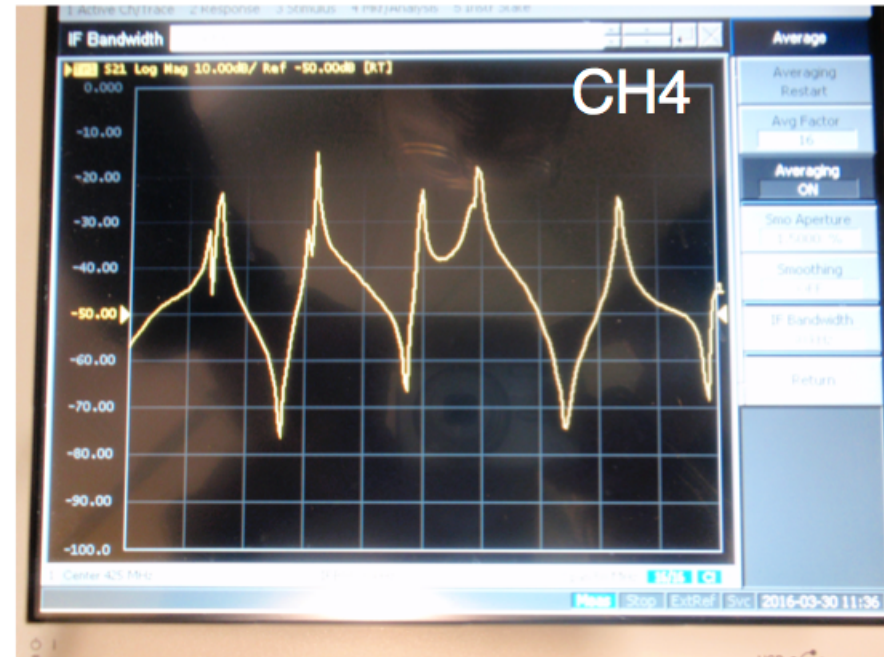
Before the rotation

406.750	407.612	415.250	416.000
425.000	429.250	429.750	441.750

Center 425MHz, SPAN 50MHz

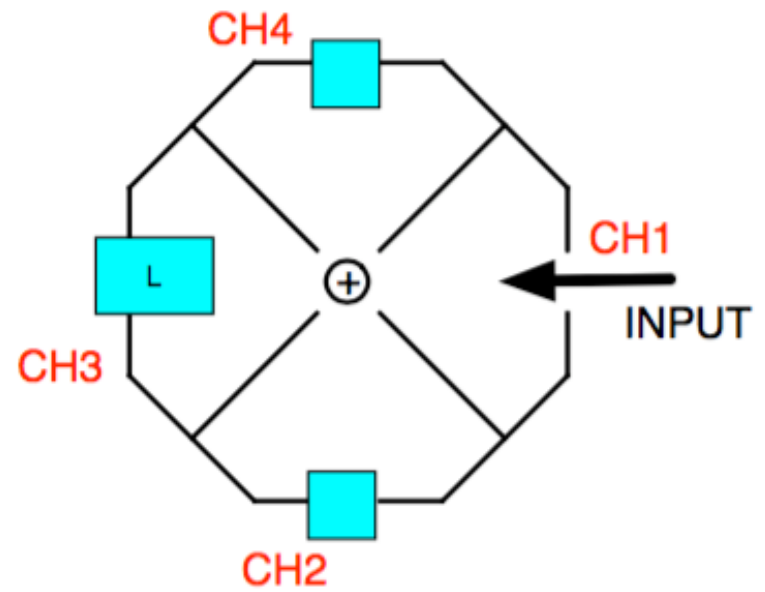
Redefined CH-number
